**United States Environmental Protection Agency
EPA New England
One Congress Street, Suite 1100
Boston, MA 02114-2023**

RE: September Monthly Report
1.5 Mile Reach Removal Action
GE-Pittsfield/Housatonic River Site

September 2006 Monthly Report

GE-Pittsfield/Housatonic River Project 1.5 Mile Removal Action

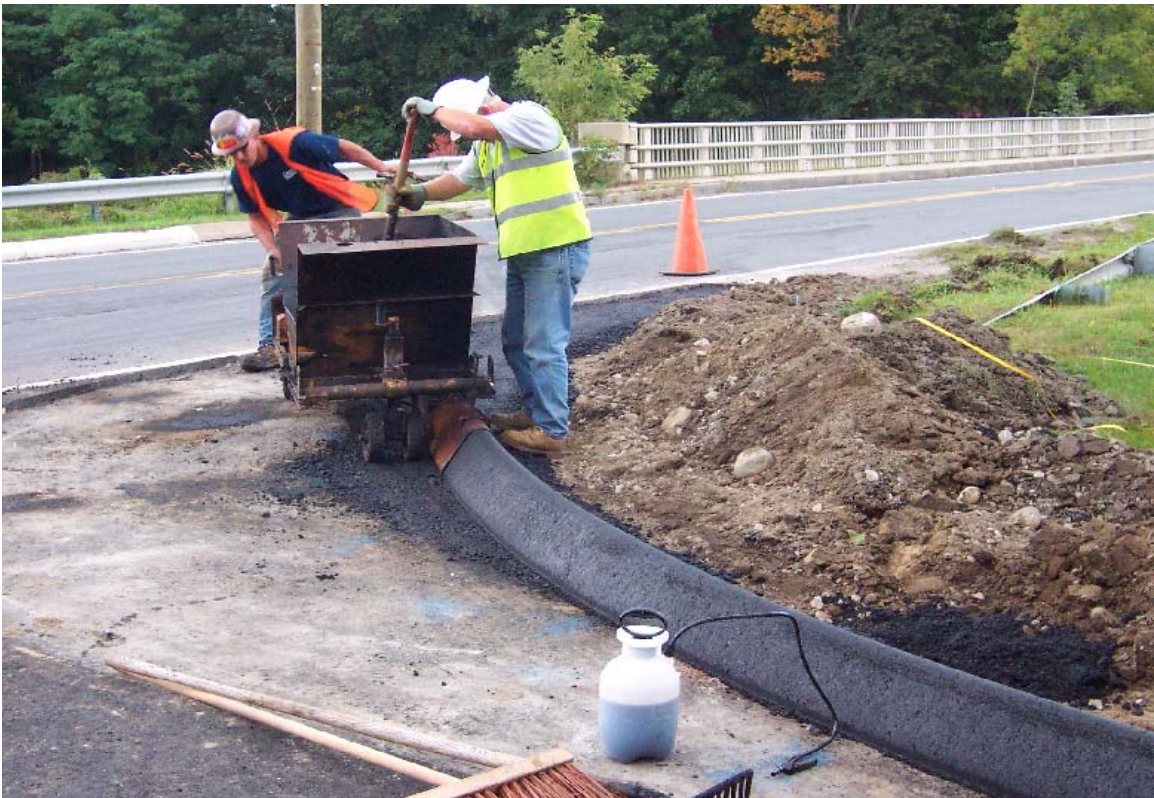
Photograph 1 – Activities Associated with the Installation of a Curb at the Entrance to Fred Garner Park

By the end of August, final restoration activities at the Fred Garner Park were well underway. During the month of September the final restoration activities at the Fred Garner Park continued. The installation of the pavement final surface course and striping of the parking lot and installation of the parking lot bumpers were completed. Also, it was decided that the curvature of the curbs that were initially installed at the entrance to the park created a narrow entrance. Therefore, it was decided that the curbs need to be re-done with a 25-foot radius to create a wider entrance and to meet the existing curb on Pomeroy Avenue. The replacement curbs were installed in September.

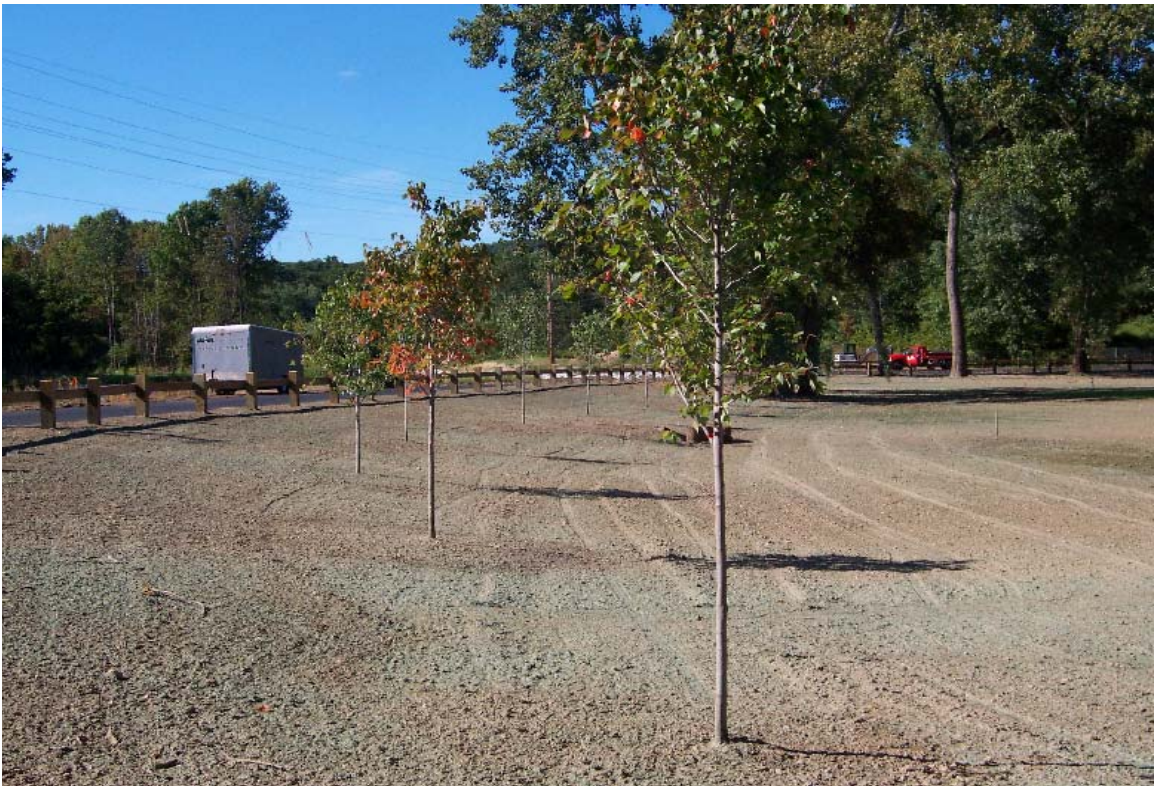
Photograph 2 – Overview of Newly Planted Red Maple Trees at Fred Garner Park

Also, the planting of the eight red maple trees and six river birch clumps in the park was completed.

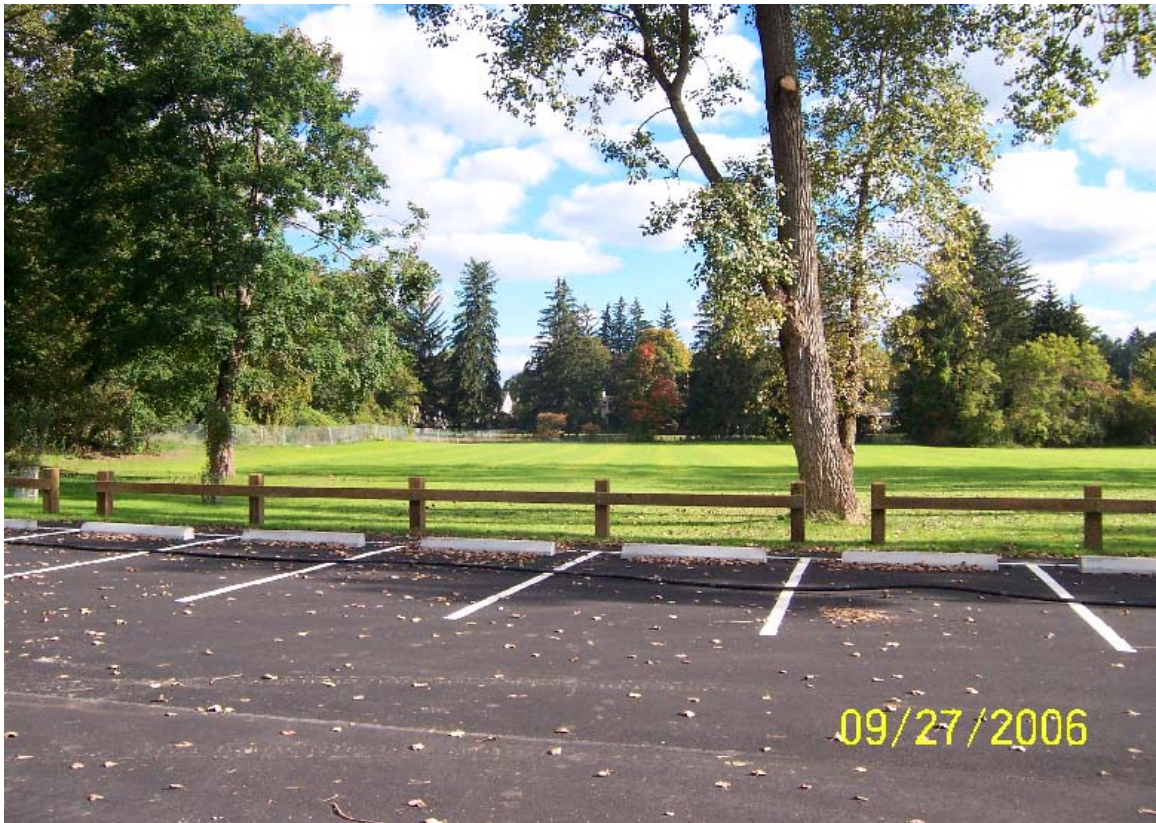
Photograph 3– Overview of Restored Fred Garner Park

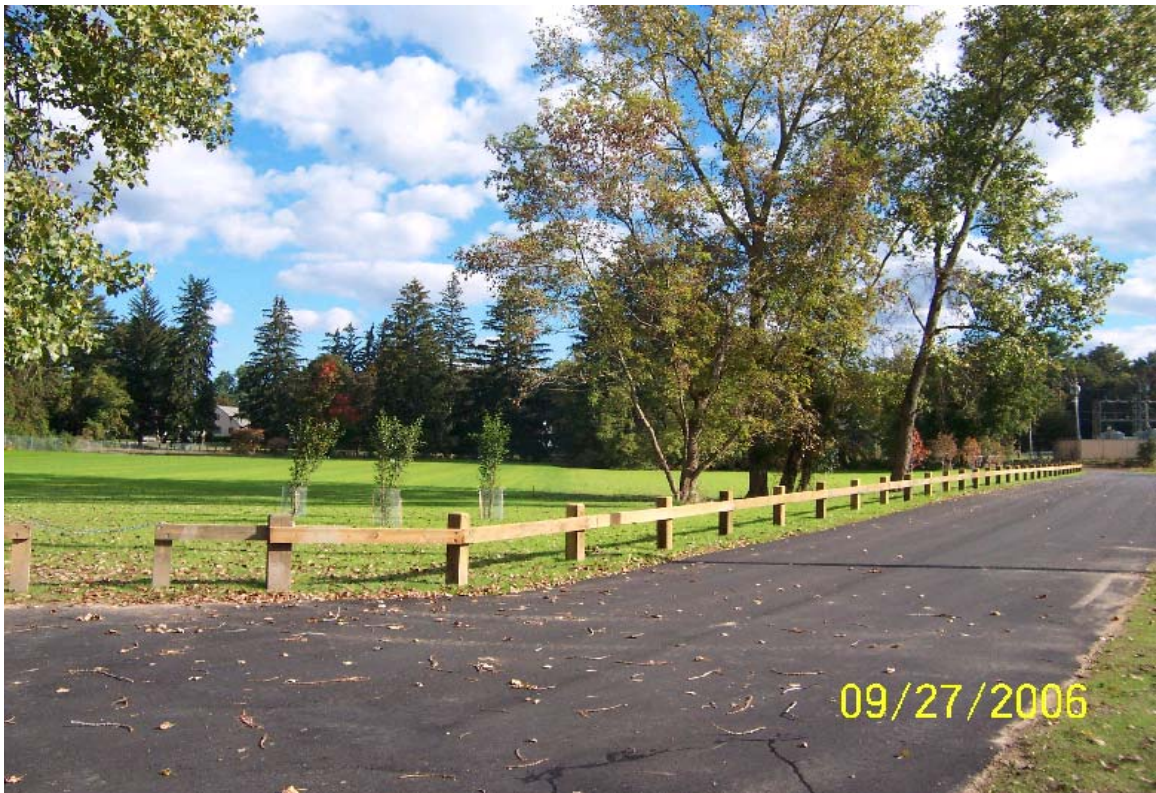
Photograph 4– Overview of Restored Fred Garner Park

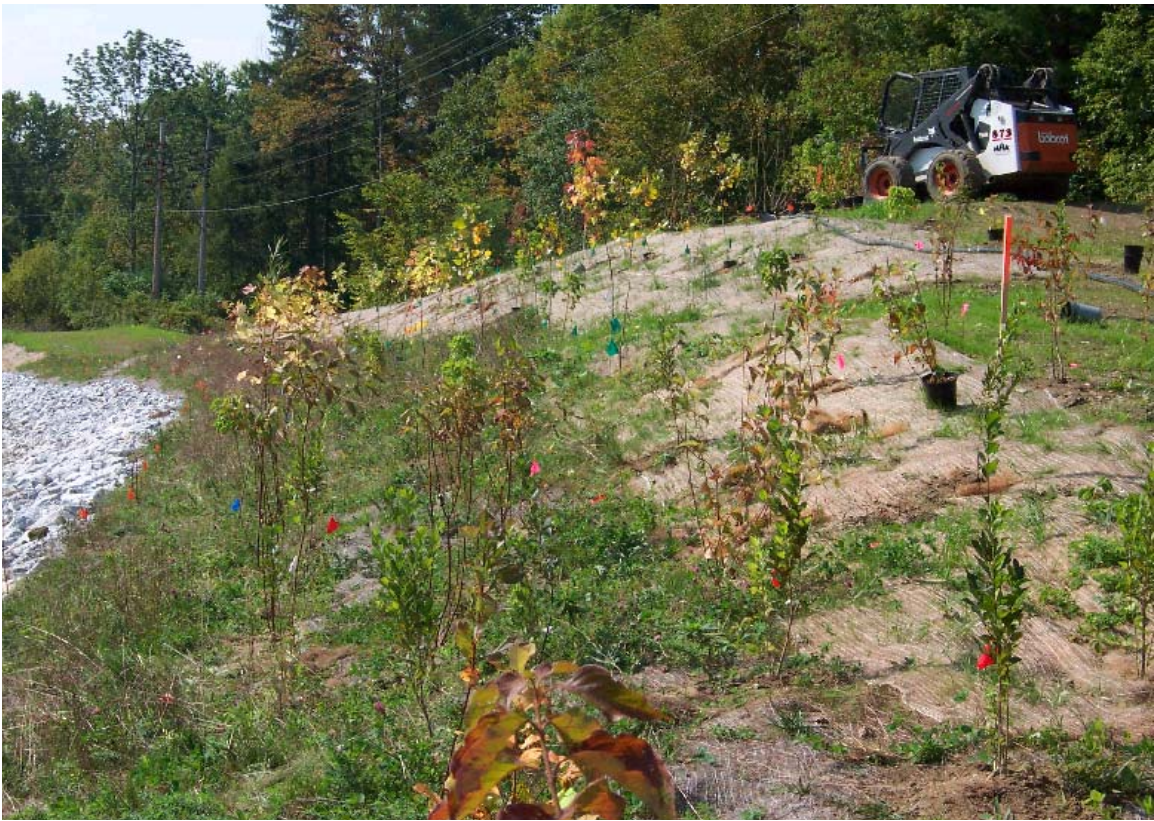
Photograph 5– Overview of Newly Re-Planted Riverbank in Fred Garner Park

Fall planting activities were initiated. The installation of trees and shrubs on the Phase 3C west riverbank, adjacent to Fred Garner Park were completed. All the disturbed areas within the new plantings were hand raked and seeded with herbaceous seed mix. The installation of the larger trees within the downstream sections of the park will be performed in October 2006. Also, the installation of the supplemental trees and shrubs on Parcel I8-23-6 in areas that were identified during the summer vegetation inspection was completed. The extra trees and shrubs were needed due to the damage caused during the GE's oxbow A and C remediation activities.

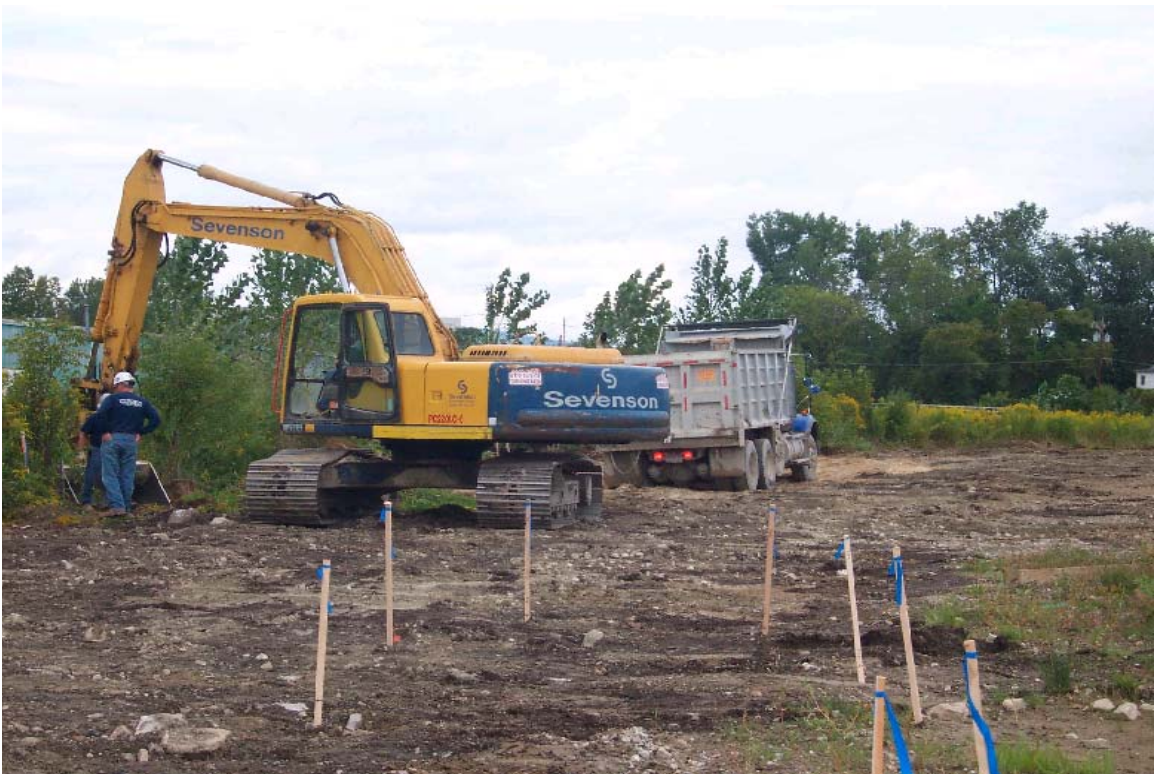
Photograph 6 – Activities Associated with the Removal of Access Roads on Parcel I8-23-6

Also during the month of August, activities associated with the removal of the access roads on Parcel I8-23-6 were initiated. During the month of September, the removal of the access roads on Parcel I8-23-6 was completed with the exception of the portion of the road from the Day Street entrance to the property just west of the drainage swale crossing, which was left in place.

In general the access roads located on Parcel I8-23-6 were constructed as follows: first geotextile was placed on the existing native sub-grade. Then an approximate six-inch layer of common fill was placed on the geotextile, followed by a second layer of geotextile and an approximate six-inch layer of dense grade. During the removal of the access roads, first the dense grade materials were removed down to the geotextile, this material was stockpiled separately and was slated for testing and potential re-use. Next, the geotextile was carefully removed and stockpiled for offsite disposal. Then the common fill was removed down to just above the geotextile layer to ensure that the native materials were not removed with the common fill. The common fill was stockpiled separately and was slated for testing and potential re-use. Lastly the remainder of the common fill and geotextile were removed, stockpiled and slated for testing and offsite disposal. To ensure that all geotextile material was removed, an approximate one to three inch layer of native sub-grade material was removed along with the common fill/geotextile. All of the removed materials were transported to Area 64 stockpile management areas.
